HISTORIC LANDMARKS COMMISSION STRUCTURE OF MERIT DESIGNATION REPORT

806 ORANGE AVENUE

SANTA BARBARA, CALIFORNIA APN 037-024-009

Designation Status: Designated a historic Structure of Merit on September 16, 2020

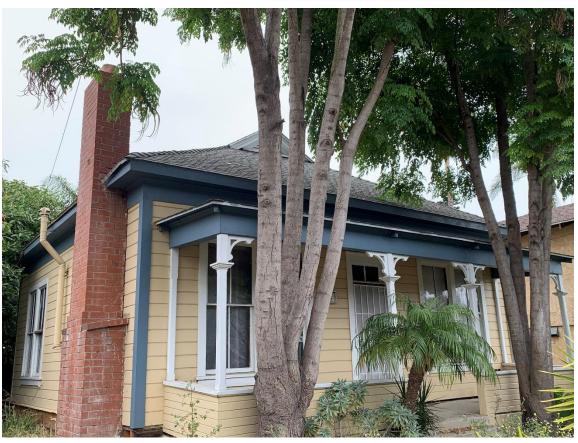
View Eastward from street at Orange ave toward front elevation. WEST ELEVATION

Property Description: This one-story Italianate house has a low-sloped, hipped roof with small gable in the center. The house features wood, shiplap siding, A full width front porch with a shed roof supported by thin porch posts with beveled corners and decorative brackets. The house features pairs of two-over-two, elongated, wood windows with thick trim and sills. The front door is capped with a divided light transom. A tall brick chimney is on the side elevation.

- •Blocky architecture, with no curved walls and a symmetrical layout;
- •A shallow, hipped roof that helps to set apart the Italianate from the other Victorian styles;
- •Long, full-width front porch that extends the living area outside;
- •Wide shiplap siding;
- •Thin, square porch posts with beveled corners and ornate brackets;
- •Two-over-two, elongated, wood windows with thick wood trim

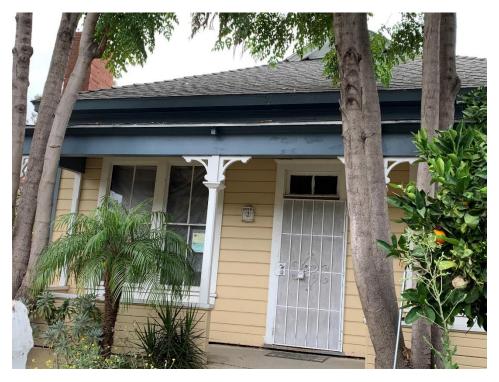
wall surface, in part due to an abundance of lumber on the west coast. The earlier versions of Italianate usually had very large weatherboards for siding because until 1872, Stearns Wharf had not been built, and all wood had to be floated ashore. One of the chief champions of Santa Barbara's Italianate was the influential mayor and architect, Peter Barber (see the photograph at the top left of this page of an Italianate building he designed in Santa Barbara.) Several examples of Italianate architecture can be found in the Brinkerhoff Avenue Landmark District as well as dotted throughout upper west side of downtown along Chapala and De La Vina Streets. Referencing the Italian farmhouse and villa, the house at 806 Orange Street embodies the following features that are hallmarks of the Italianate style:
